## St Pius X Church Structural Arches

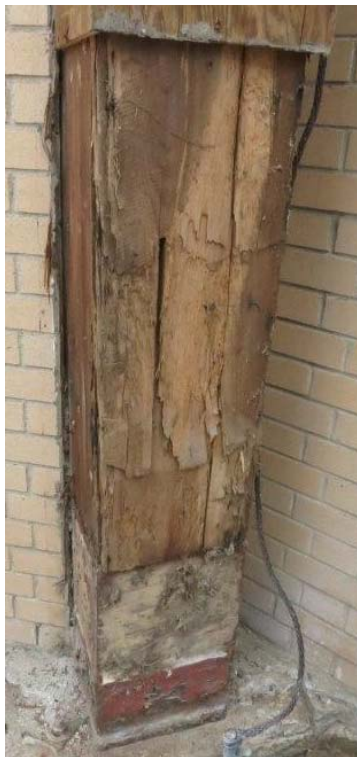
The church structural arches were inspected and varying amounts of rot were discovered in all four outside (south and north) wall arches and de-lamination was evident in three of the four outside arches.

*Figure 1 - Timber arch delamination*

However, there is still a need to stop the rot in all arches and to reinforce all of the existing timber arch-to-foundation connections. This remedial work requires warmer weather and will be completed in spring 2017.

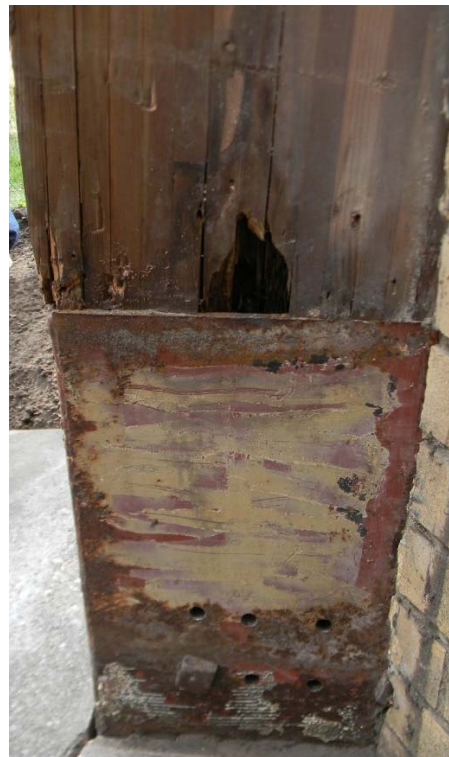
Examination of the church structural arches led to test boring into timber to determine extent of rot. A detailed engineering computer analysis of the strength of the remaining wood in the timber arches determined reinforcement of the southeast arch was required to make the church is structurally sound under all Alberta building code conditions of snow and wind loading as well as with full people loads in the balcony. The reinforcement of the southeast arch has been completed.

*Figure 2 - Timber arch rot inside support shoe*
